S-217 Costen Tenant House No. 2 Near Wellington Private

c. 1800-1815

Maryland Historical Trust State Historic Sites Inventory Form

Survey No.
S-217

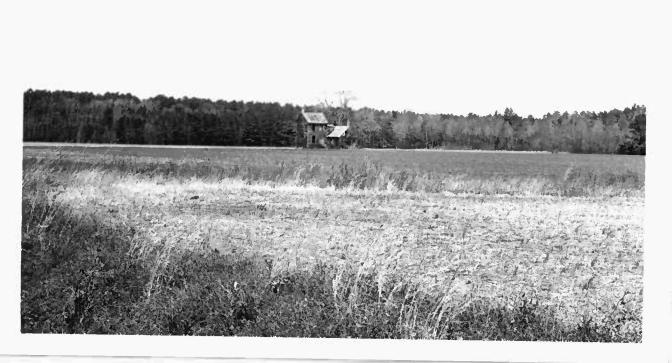
Costen Tenant House No. 2
Near Cokesbury, Somerset County
South Elewation
2/84 Paul Touart
Neg./Maryland Historic Trust

The south side of the house is detailed in a similar manner but without as much decoration around the door. The six-panel back door is framed by a simple door surround. Window openings remain in the same location but only one section of sash remains in place. The cornice is finished with the same end boards, modillion blocks and dentils, but the fascia was left plain. The south side of the c. 1890-1900 addition is primarily covered by the single-story kitchen wing, which rests on a brick pier foundation and is sheathed with a combination of beaded and plain weatherboards. The west side of the kitchen has two openings. A six over six window pierces the left bay, while an old door opening (now window) occupies the right bay.

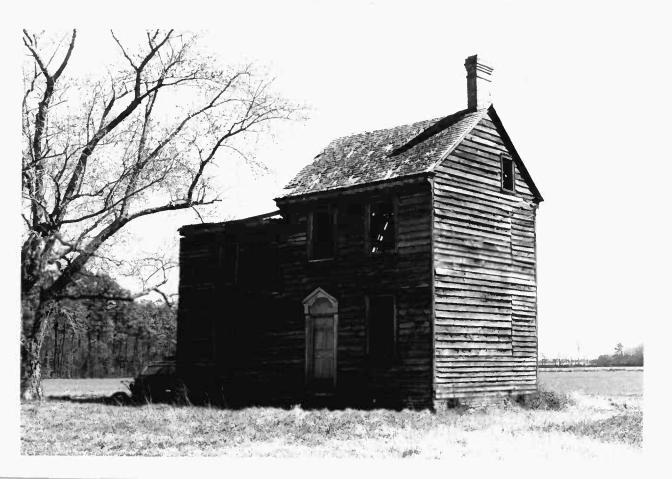
Costen Tenant House No. 2 Near Cokesbury, Somerset County Northwest Corner 2/84 Paul Touart Neg./ Maryland Historic Trust

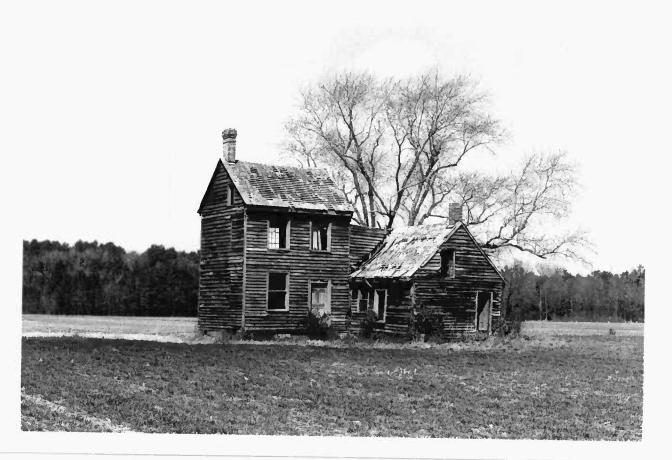
Costen Tenant House No.2 Near Cokesbury, Somerset County South Elevation 2/84 Paul Touart Neg./ Maryland Historic Trust

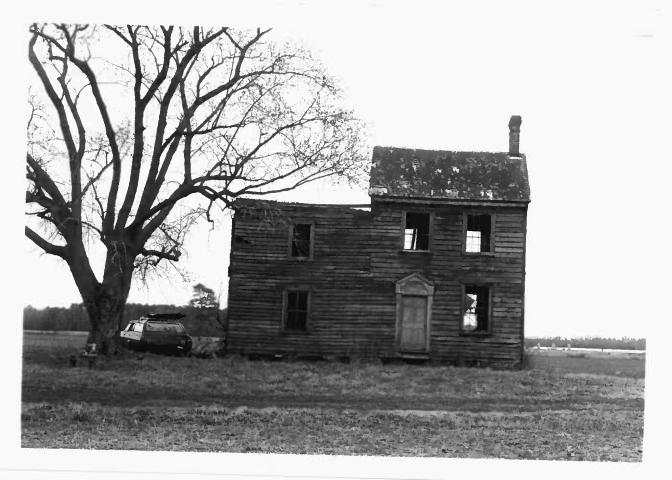
Costen Tenant House No.2 Near Cokesbury, Somerset County North Elevation 2/84 Paul Touart Neg./ Maryland Historic Trust

The north (main) elevation is three bays across with the western two bays comprising the c. 1800-1810 house. A pedimented entrance with a semi-circular transom light and dentil molding under the cornice tops a raised six-panel door. Directly west (to the right) of the entrance bay is a 12/12 sash window and located above are two 12/8 sash windows. Stretching across at the base of the roof is a finely crafted boxed cornice, embellished with crown molding, end boards and delicate modillion blocks. In addition the facia is scored with a pattern of vertical lines interupted by six-point stars. Under the modillions is a row of dentils. The c. 1890-1900 addition is lighted on both floors by 2/2 sash windows. The roof has fallen in.

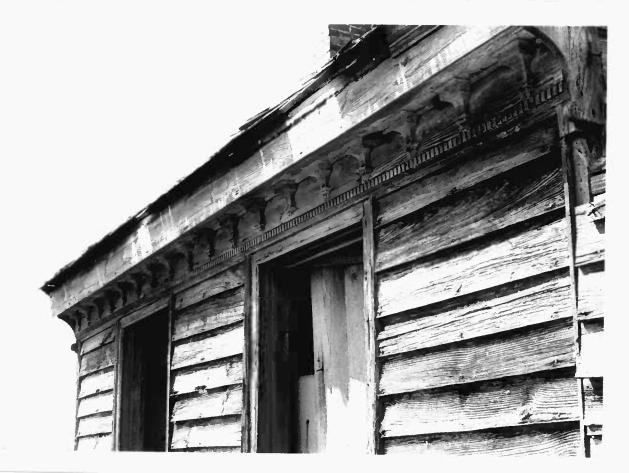
Costen Tenant House No. 2 Near Cokesbury, Somerset County Eave Detail 2/84 Paul Touart Neg./Maryland Historic Trust

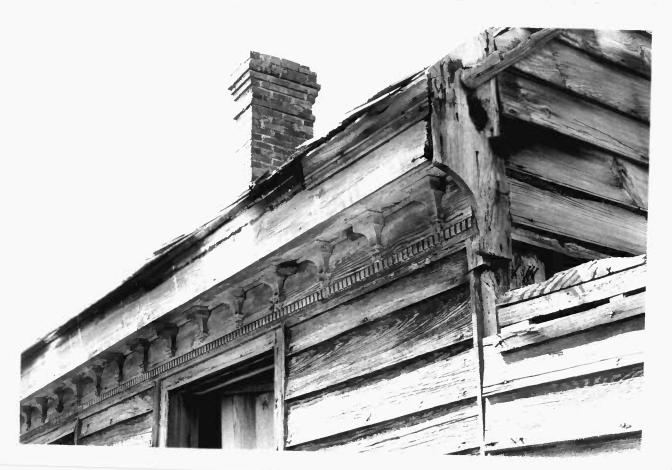
Costen Tenant House No.2 Near Cokesbury, Somerset County Cornice Detail 2/84 Paul Touart Neg./ Maryland Historic Trust

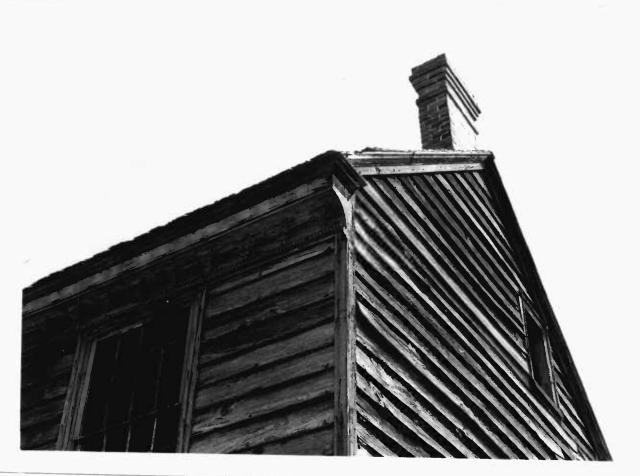
Costen Tenant House No. 2
Near Cokesbury , Somerset County
East Elevation
5/84 Paul Touart
Neg./Maryland Historic Trust

The east side of the kitchen wing is pierced by two window openings, one of which has been boarded up.

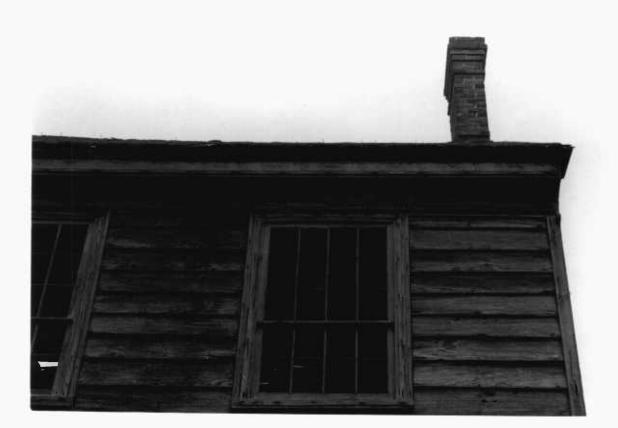
William Costen Tenant House No. 2 Near Cokesbury, Somerset County North Cornice Photographer, Paul Touart, 1/85 Neg./MD Historical Trust S-217

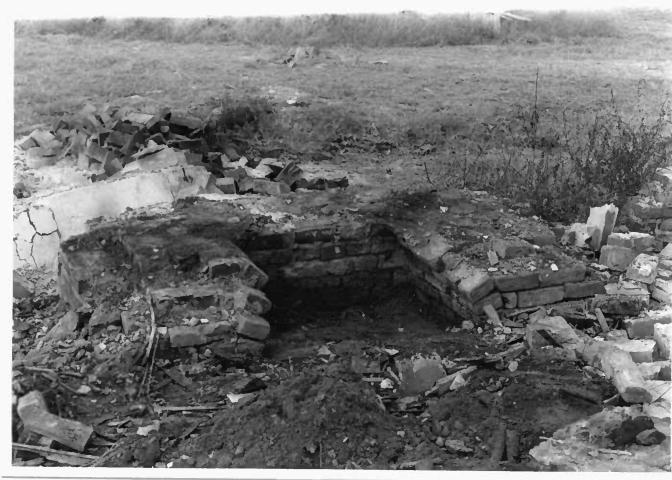
Arched Chimney Support

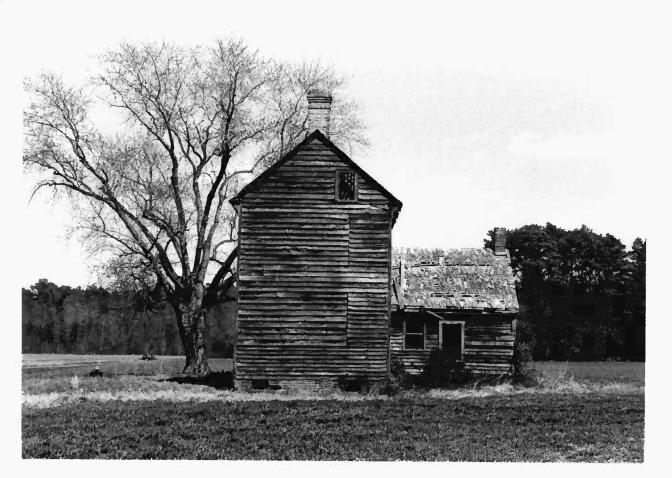
Costen Tenant House No. 2 Near Cokesbury, Somerset County West Elevation 2/84 Paul Touart Neg./ Maryland Historic Trust

The west gable end of the house is plainly finished with a combination of beaded and plain weatherboards. Two seams in the siding to the right of the internal chimney in the location of previous windows. A small window opening still lights the attic to the right of the stack. A molded barge board finishes the gable end, while a narrow brick chimney is finished with a corbelled cap.

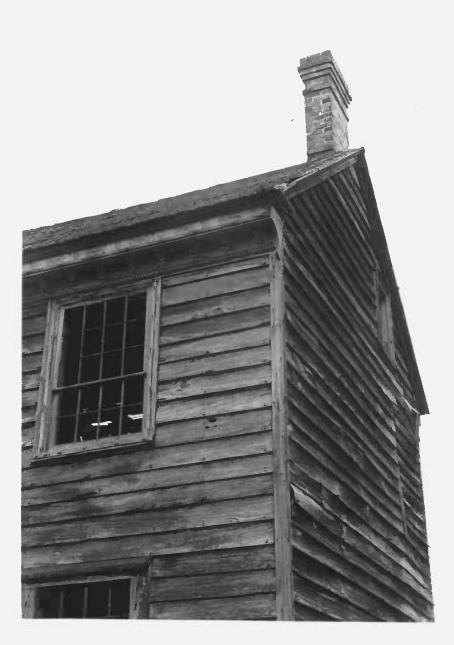
William Costen Tenant House No. 2 S-217
Near Cokesbury, Somerset County
Northwest corner
Photographer, Paul Touart, 1/85
Neg./MD Historical Trust

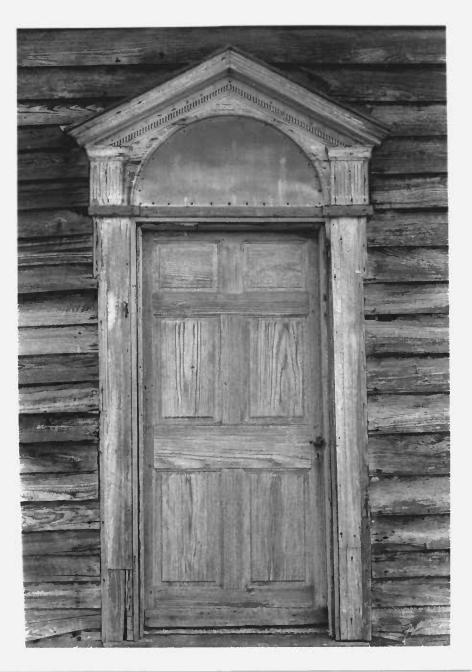
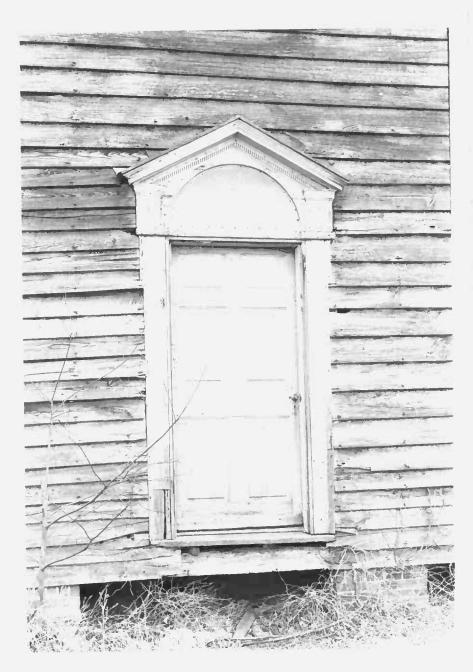
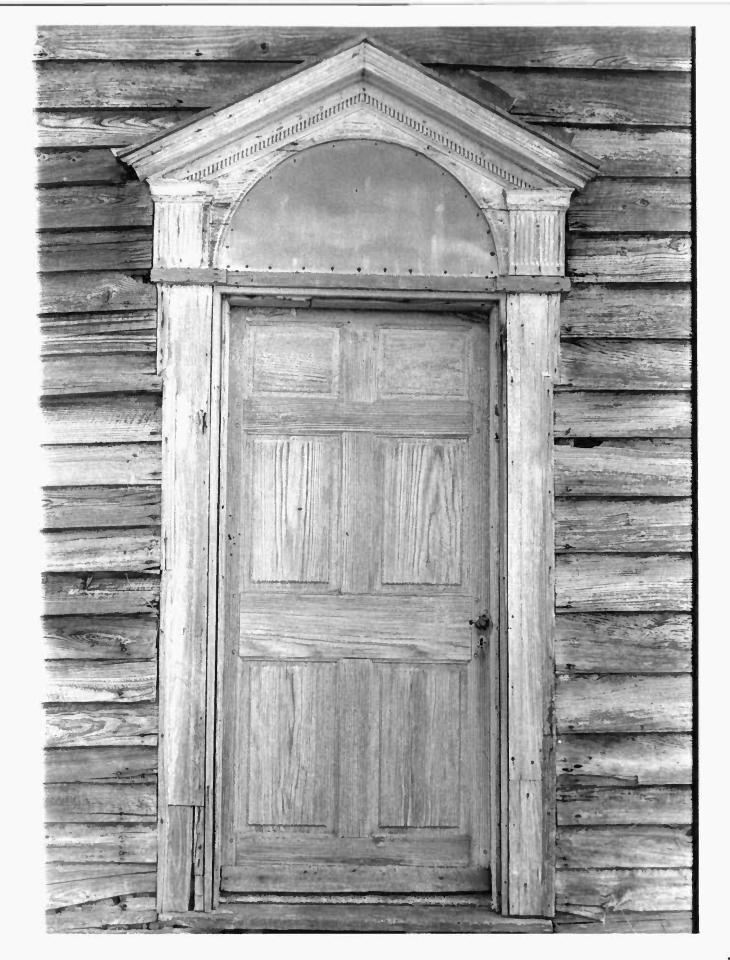
William Costen Tenant House No. 2 S-217
Near Wellington, Somerset County
Front Door-North Elevation
2/84 Paul Touart
Neg/MD. Historical Trust

Costen Tenant House No.2 Near Cokesbury, Somerset County Front Door-North Elevation 2/84 Paul Touart Neg./ Maryland Historic Trust

William Costen Tenant House No. 2 S-217
Near Wellington, Somerset County
Front Door
2/84 Paul Touart
Neg./MD Historical Trust

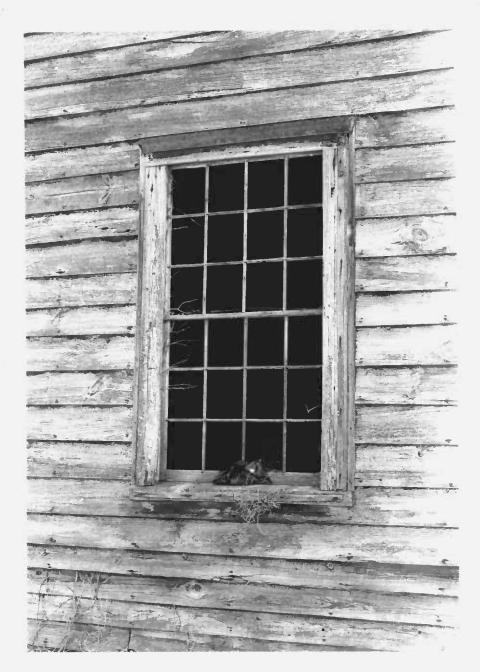
Costen Tenant House No.2 Near Cokesbury, Somerset County North Window 2/84 Paul Touart Neg./ Maryland Historic Trust

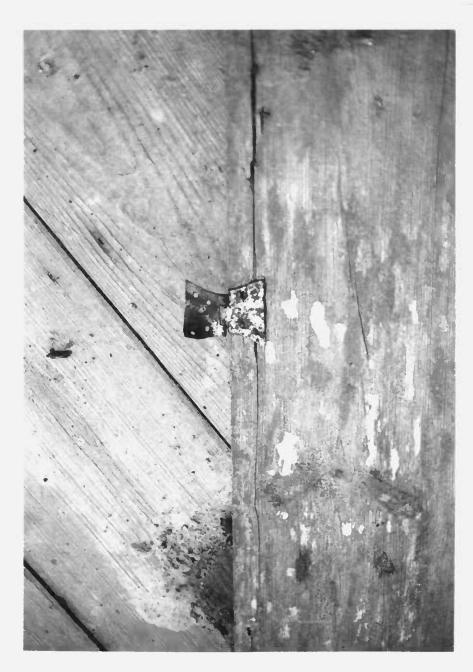
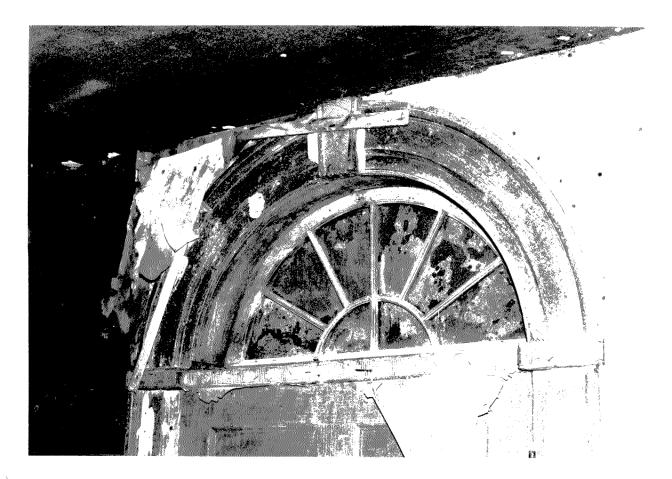
Costen Tenant House No. 2
Near Cokesbury, Somerset County
Front Door Transom
2/84 Paul Touart
Neg./ Maryland Historic Trust

Costen Tenant House No. 2
Near Cokesbury Somerset County
Front Door Transom
2/84 Paul Touart
Neg./ Maryland Historic Trust

Inside the c. 1800-1810 portion, the first floor walls are covered with flat panel wainscoting below the chair rail. Ovolo molded back band surrounds the frame the east wall door as well as the door openings on the front and rear walls. The entrance transom is treated in a special way with a decorative keystone block that interupts the header molding. The transom muntins spread out in a radiating spoke pattern.

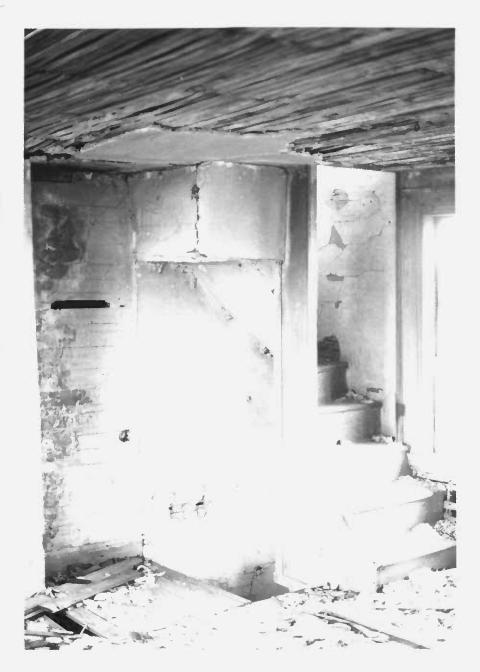
Costen Tenant House No.2 Near Cokesbury, Somerset County 2nd floor stair 2/84 Paul Touart Neg./ Maryland Historic Trust

The stair rises under a sloped plaster soffit to the second floor. The second frail and covered with plaster over riven oak lath and finished with simply molded chair rail and baseboard. The stair continues to the unfinished attic. Each pair of sawn raf-

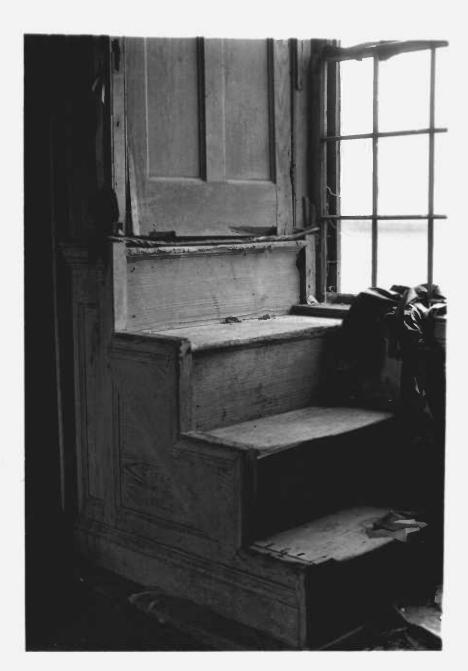
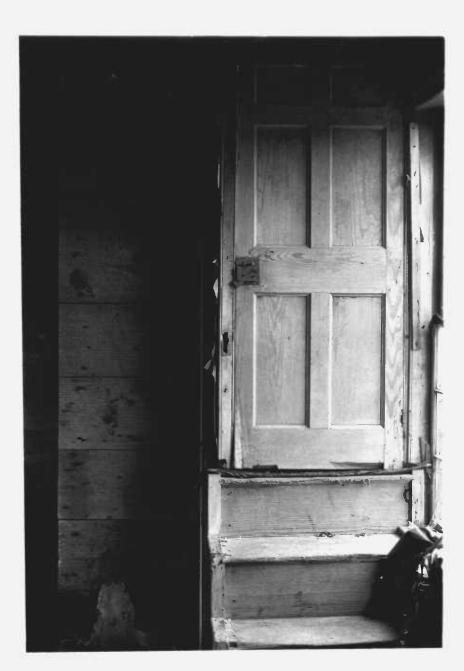
Costen Tenant House No. 2 Near Cokesbury, Somerset County Corner Stair 2/84 Paul Touart Neg./ Maryland Historic Trust

Costen Tenant House No.2 Near Cokesbury, Somerset County Corner Stair

The stair is located in the northwest corner with three exposed steps. The remaining winder stair is enclosed behing by a flush six-panel door with spring lock. The mantel has been removed as have the stair balusters and handrail.

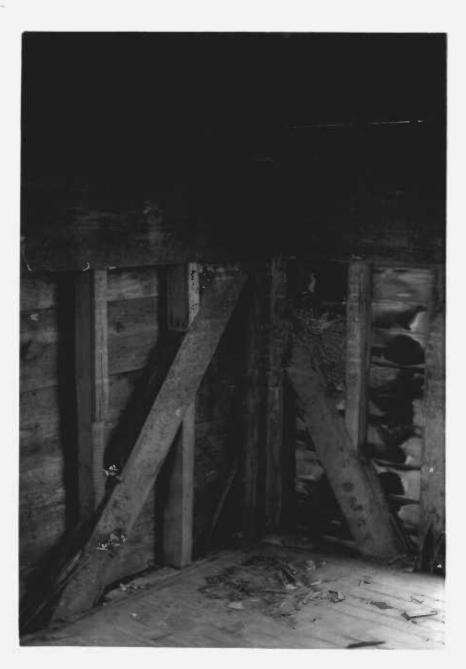
William Costen Tenant House No. 2 S-217
Near Cokesbury, Somerset County
Ell corner posts
Photographer, Paul Touart, 1/85
Neg./MD Historical Trust

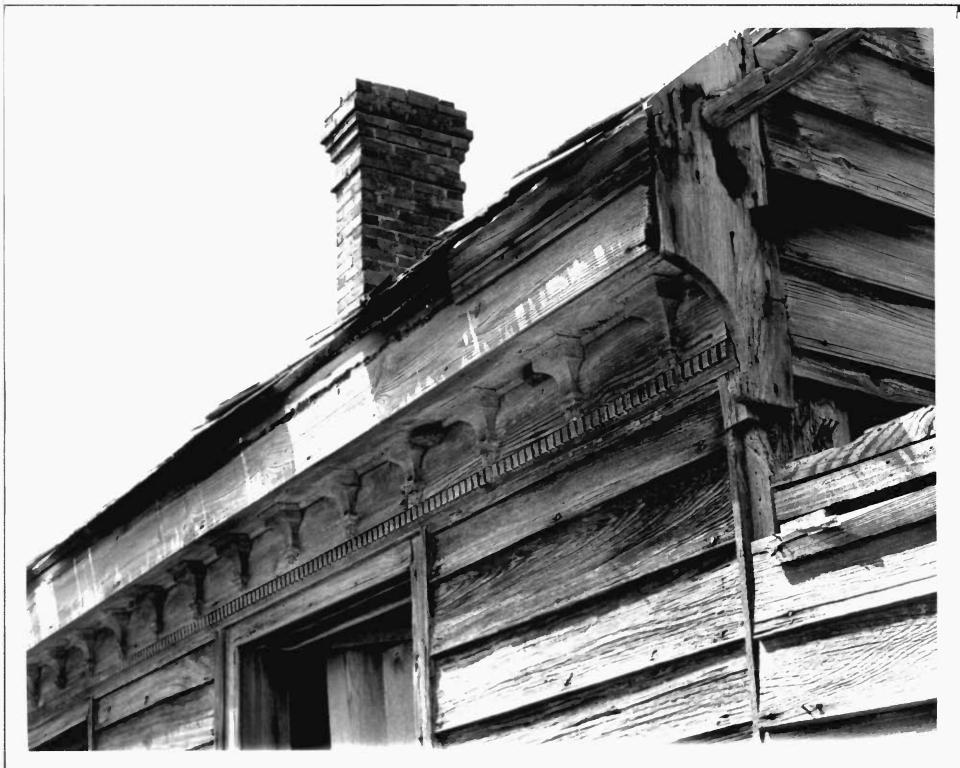
William Costen Tenant House No. 2 S-217
Near Wellington, Somerset County
Cornice - South Elevation
2/84 Paul Touart
Neg./MD Historical Trust
